Rehabilitation of RCC Jetty Gopalpur Port, Orissa

A Case Study

Rehabilitation of RCC Jetty

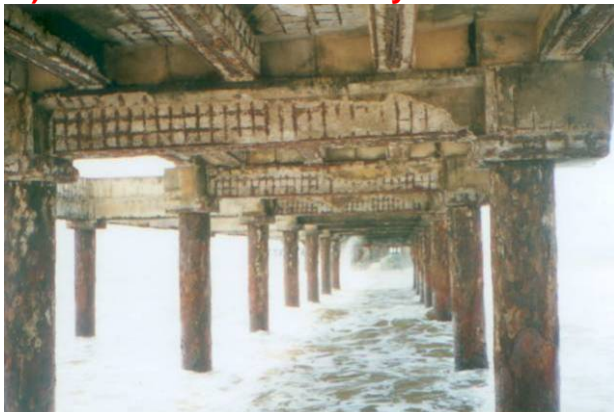
1.) Initial Condition Survey

The RCC Jetty at Gopalpur Port, Orissa, with a total length of 445 m is used to unload cargo by barge. The structure consists of piles, RCC beams and a RCC slab. All elements of the structure showed severe distress due to rebar corrosion as a consequence of chloride ingress up to and beyond the depth of the steel rebars. The same was further facilitated by a moderately dense concrete, an abundant number of concreting joints and no proper maintenance since the commissioning of the structure.

Full view of underside of Jetty

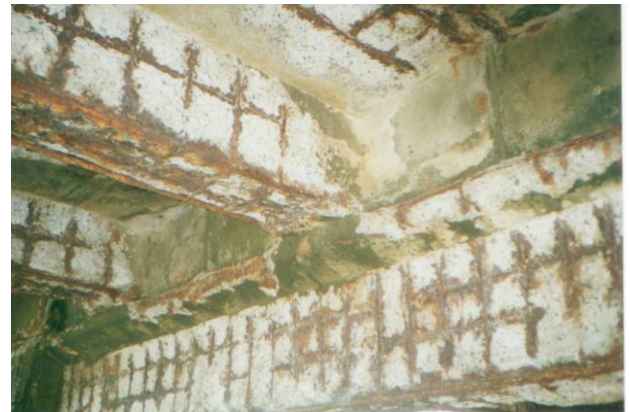
Detailed view of underside of Jetty
